② THIS IS HOW YOU SONIC

An intrepid cruiser looking for a bottom free of barnacles sets off to determine if an Ultrasonic sound-wave system provides true anti-fouling protection. BY WALLY MORAN

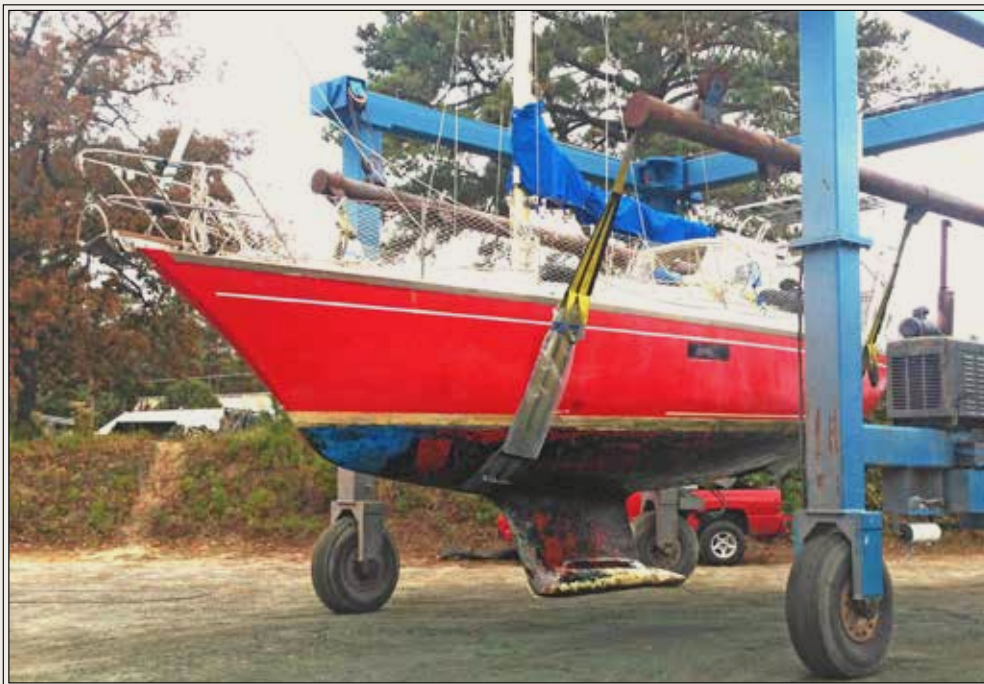
For close to a year, *Gypsy Wind* went without bottom paint, the only protection came from the Ultrasonic unit. Once hauled, the exposed layers of old bottom paint, offering no antifouling protection, were visible (top). The only significant area of barnacle growth after this extended period was near the skeg (bottom).

My original plan was to haul the boat in Virginia, paint the bottom, and then see how the unit functioned on a trip south down the Intracoastal Waterway. But an unfortunately timed low tide in Hampton, the marina's rather shallow lift well, and time constraints dictated that I would only be able to haul and clean the hull, not paint it.

Fine. I'd haul in Miami once I'd arrived, and in the interim, as the power wash and scraping took off the last of my ablative paint, I would see what the unit could do with no bottom paint. We were going, so to speak, bare bottom to Miami.

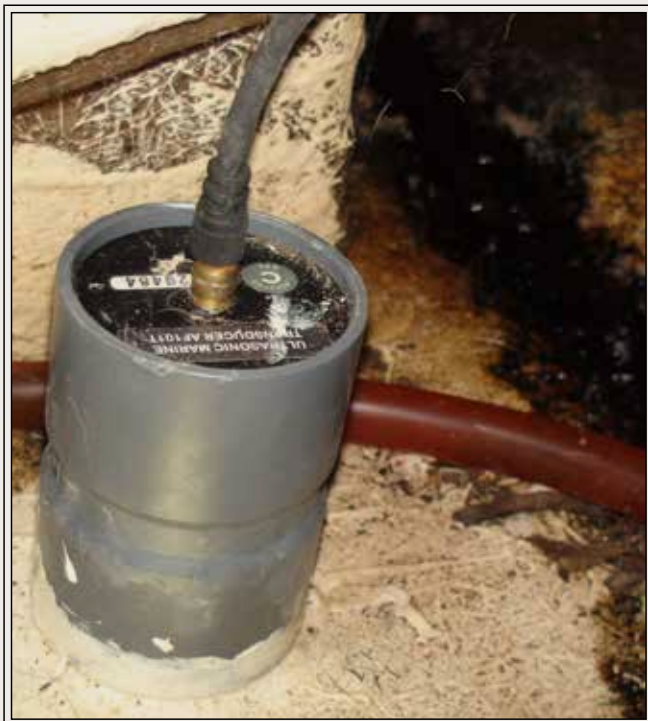
Aboard my 34-footer, *Gypsy Wind*, I installed a pair of transducers (left). Where you position them is critical to the effectiveness of the system. When installing, wriggle the unit into the epoxy to eliminate any air bubbles. The heart of the Ultrasonic system is the control box (right). Wiring is simple, with the power line clipped into the bottom of the unit, and the transducers into the top.

In the fall of 2014, I installed an Ultrasonic system sized for my 1975 Dufour 34, *Gypsy Wind*. The unit is comprised of a control box, two transducers, and the associated wiring connecting them. I epoxied the transducers directly to the hull per the instructions for my boat size, with one forward and another aft. The control box was placed close to the battery compartment to minimize wiring runs and reduce power loss to the transducers.

The basic wiring was quick and easy. The entire installation took no more than two hours, not including the setup time for the transducers' epoxy bedding. I mounted the transducers inside the boat, with one about 8 feet aft of the bow and the other in the engine room, slightly aft and to port of the keel. Placing one too close to the keel apparently interrupts the signal. Everything required was included—something more manufacturers need to do, as it saves on trips back to the store for the bits and pieces most of us invariably forget on any project.
